Procedure for Removal and Replacement of Keel Bolts and Short Bolts.

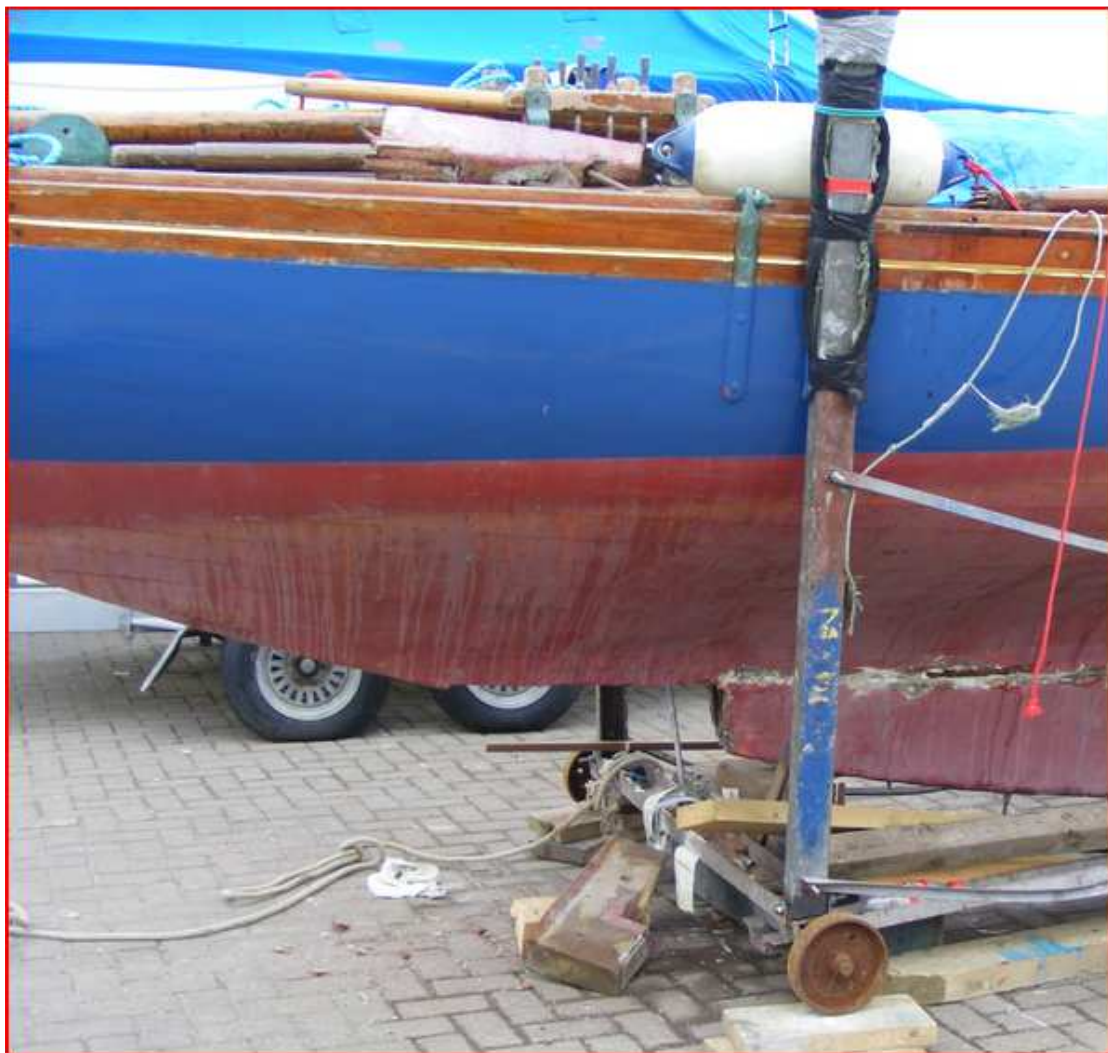
1. Firstly the cradle had to be adjusted so that the lead ballast could pass between the front and back cradle cross beams. In the case of Rosemary the gap had to be 76 inches. Two new bolt holes were drilled in the right and left cradle base so that the rear beam could be moved back. The boat was jacked up so that wooden blocks could be placed under the back of the lead keel and the boat was clear of the rear cradle beam. The boat was then propped, the cradle cross beam was disconnected and moved back by about 3 inches, and bolted back in place. The boat was then lowered back down so that the aft dead wood was sitting on the rear cradle beam.
2. To drop the lead ballast the front dead wood had to be removed first. The boat was jacked up so that the front dead wood was clear of the cradle. Wooden blocks were placed under the lead keel.

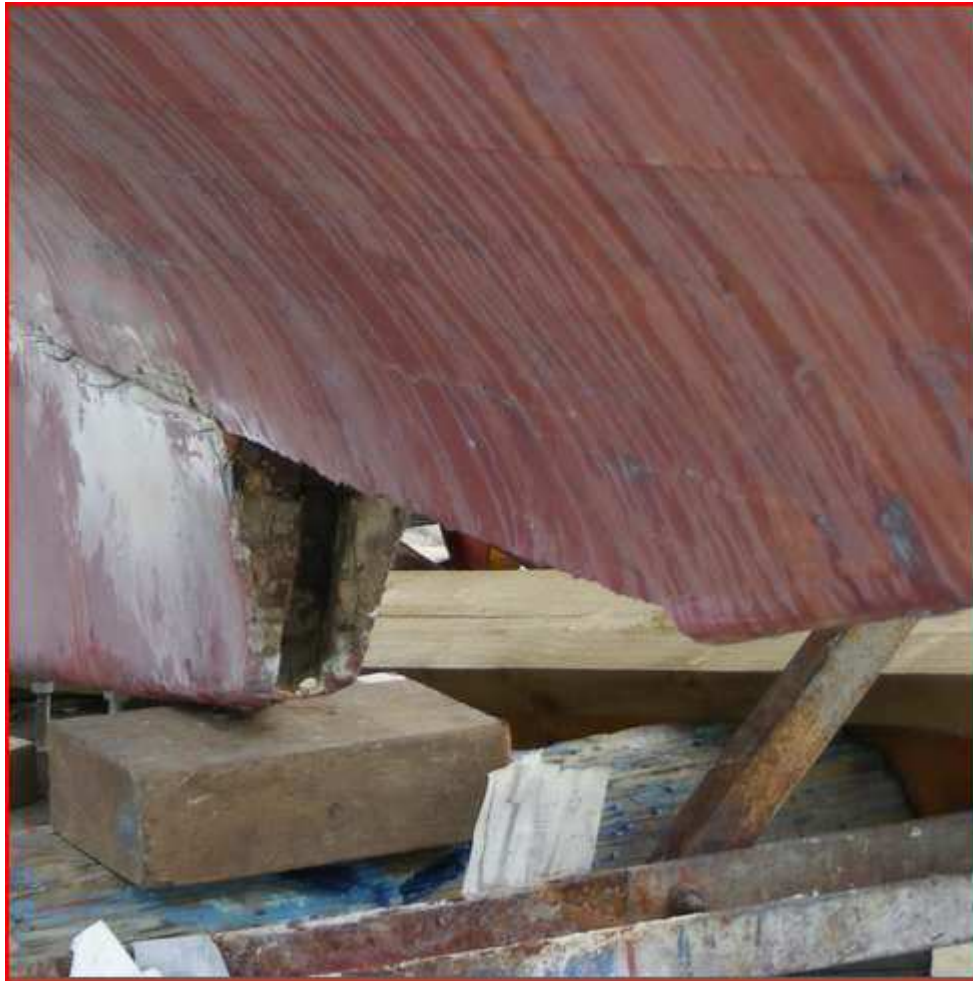
The front dead wood was attached to the wooden keel by two bolts, one of which was near the mast step (in some 17's it is actually in the mast slot). The nuts were treated with WD40 and heated using a heat gun before they were opened. Once the bolts were removed the dead wood was disconnected.

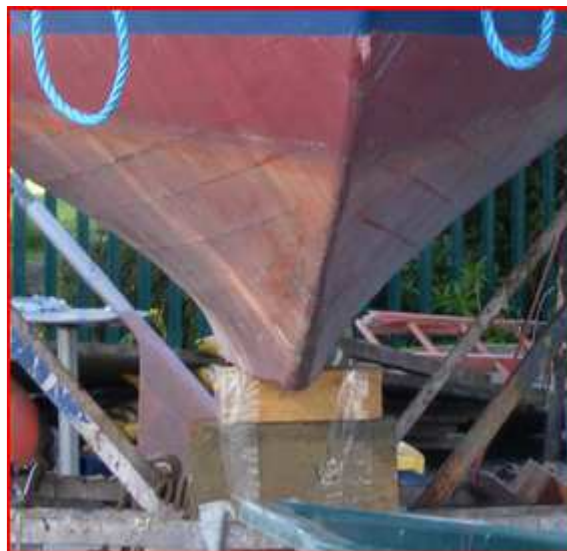
3. A number of wooden blocks were placed on the front cross beam of the cradle. This acted like a false dead wood. The boat was lowered back down as shown in the photo below.

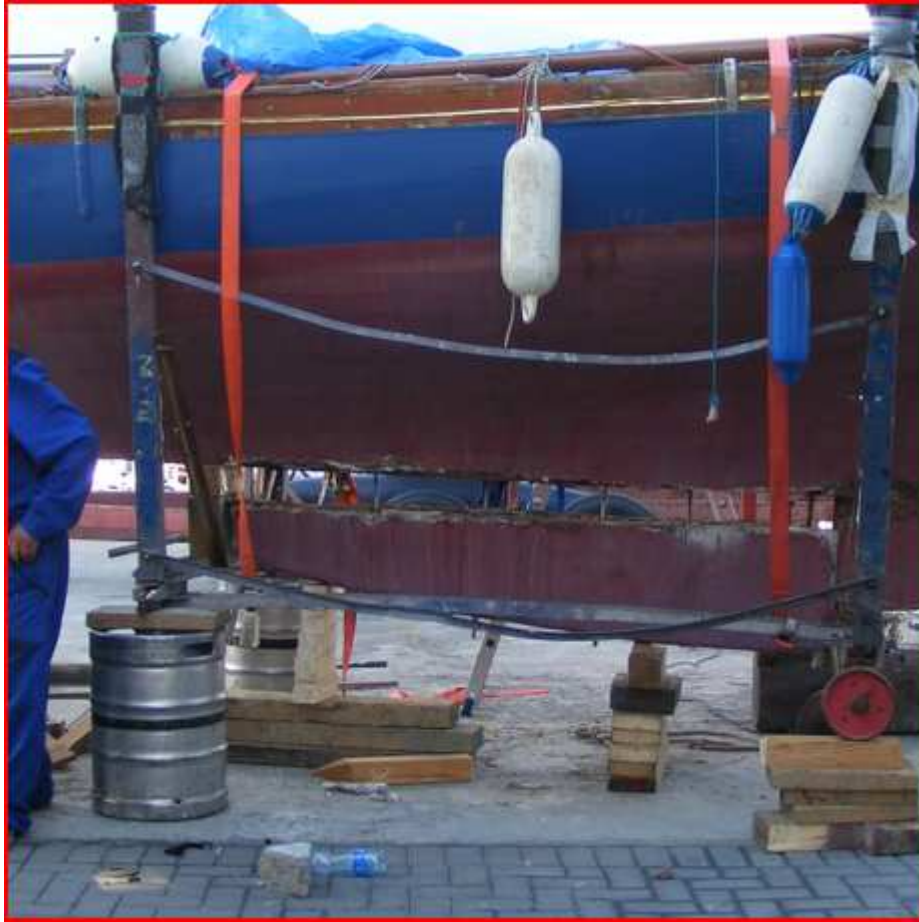
4. For stability the boat was then strapped down to the cradle using cargo straps, before the cradle was jacked up on to beer kegs. This was done in order to get enough clearance to remove the keel bolts.

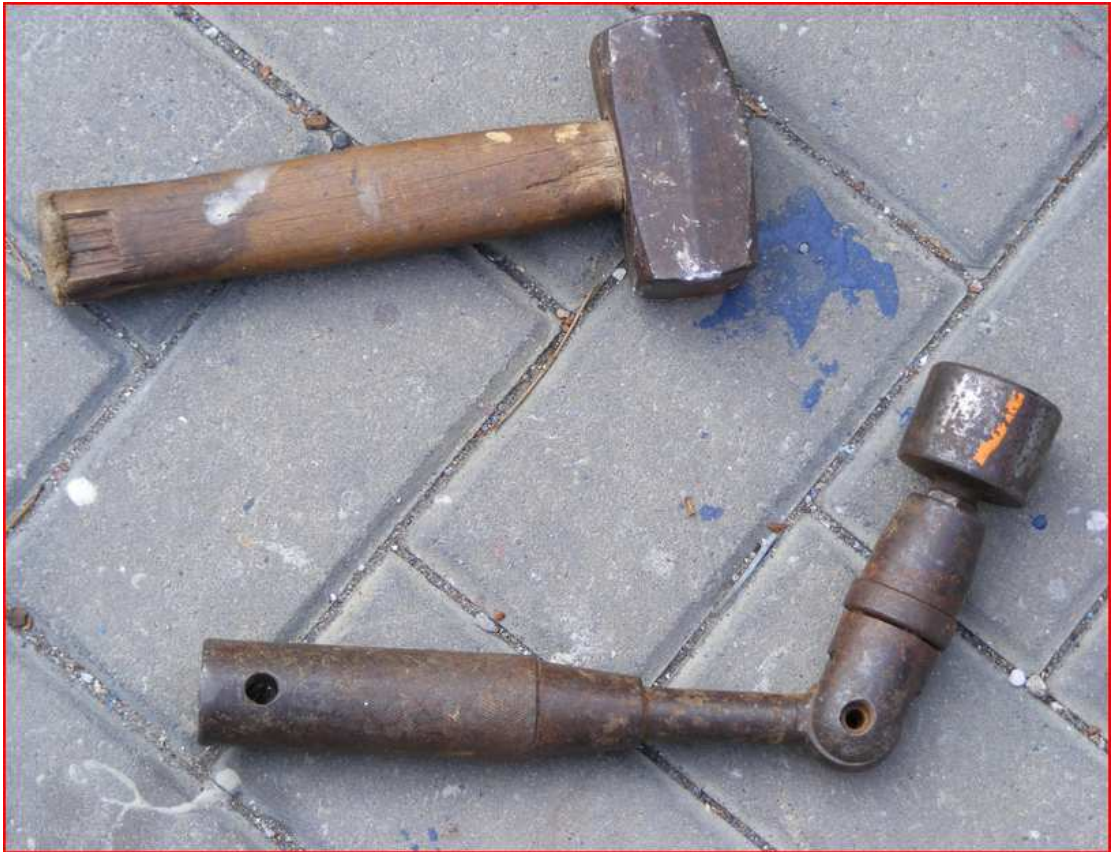
5. Inside the boat the old paint was removed from the keel bolts, the nuts were then dosed with WD40 and heat treated using a heat gun. The nuts were opened using the tool shown in the photo below (owned by Paddy Cronin). It had a hollow handle into which a bar could be inserted for leverage and had a universal joint so that the bar could be manipulated in tight spaces. It came with a set of imperial sockets. In Rosemary the nuts and bolts were bronze and the nuts opened without much hassle.

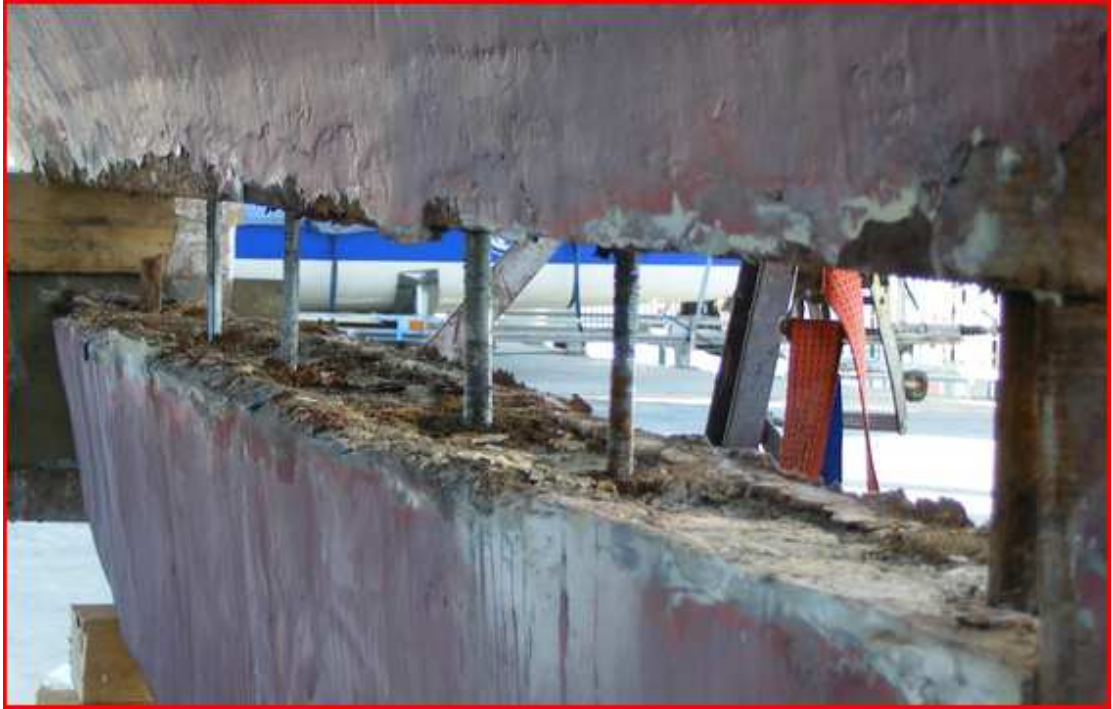
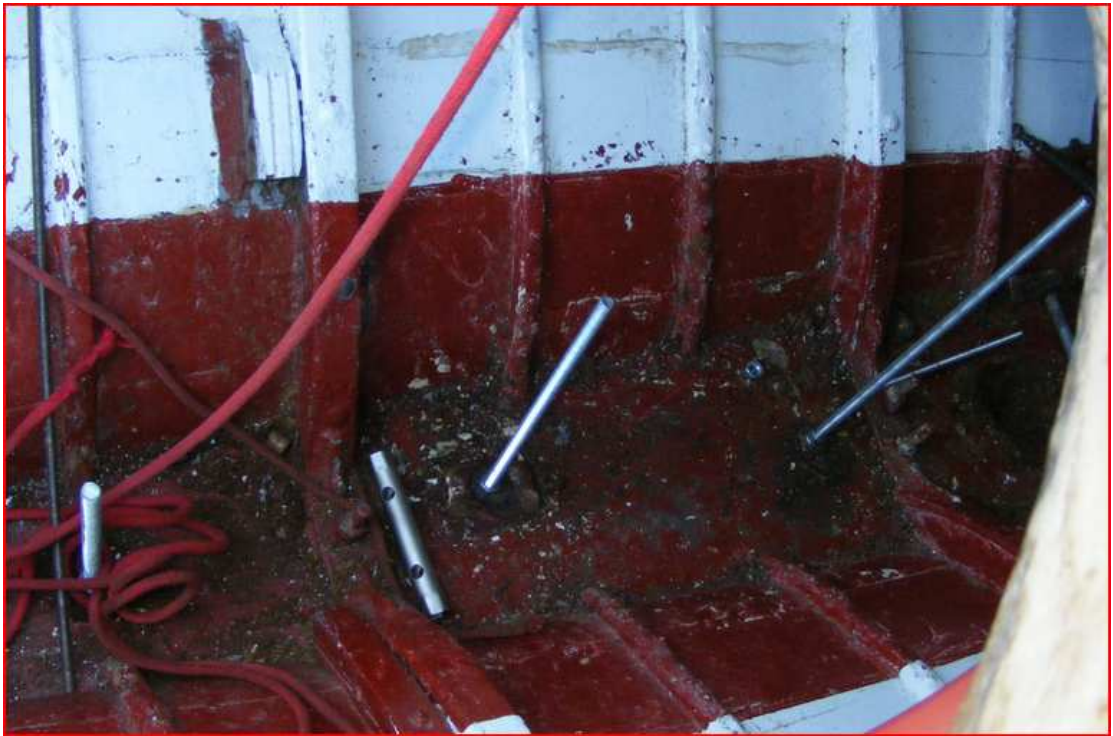
7. As each keel bolt was released, it was replaced with a length of steel treaded bar with a nut and washer on each end. When all the bolts were knocked out the lead could then be dropped. Its descent was controlled by loosening the nuts on each treaded bar. A tube spanner was the handiest tool for this job. The threaded bar also ensured that the alignment of the bolt holes in the lead ballast with the corresponding bolt holes in the wooden keel was retained. **Once the ballast was lowered it was supported from the ground up, with wooden blocks under the lead. It was important to have no strain on the wooden keel as the short bolts were removed.**

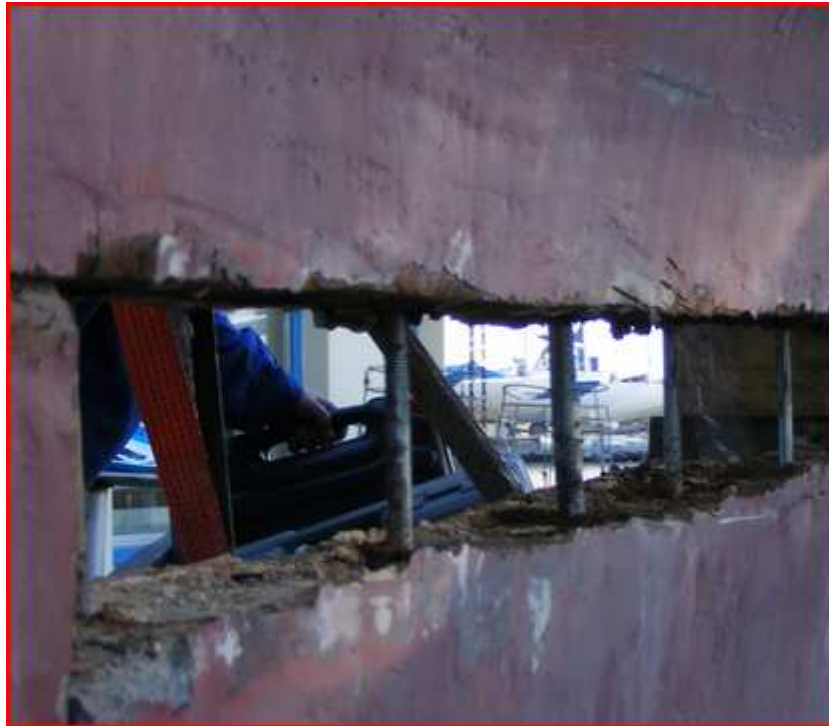
8. As the average length of the short bolts was approximately 18 cm, the ballast was only lowered to about 25cm from the wooden keel.

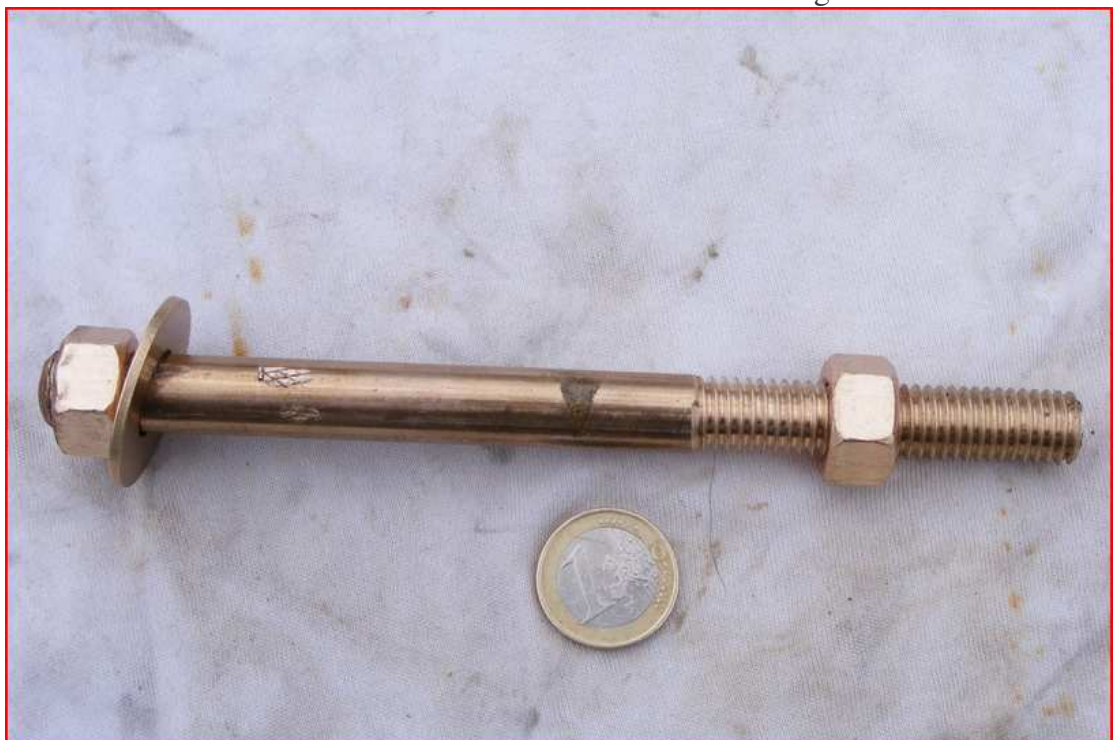
9. In order to retain structural integrity each short bolt was removed and replaced with a new bolt, before the next old short bolt was removed. Because the floors in Rosemary were bronze, the new bolts were made from smooth bronze bar (imperial) purchased in the UK. The bar came with UNC nuts and we threaded it with a UNC die. A twist of caulking cotton was

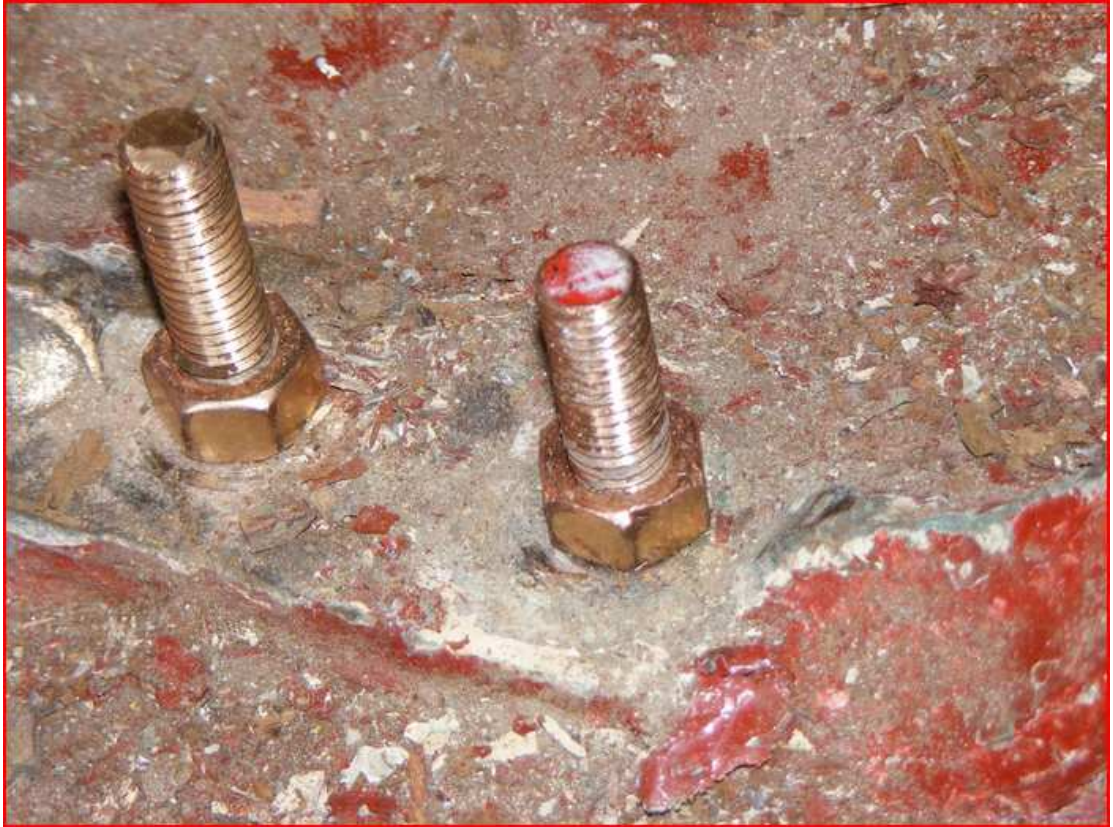
placed at the end of each bolt. Sikaflex was gunned into the bolt hole and then the bolt was driven home. A twist of caulking was placed under the nut before it was tightened down.

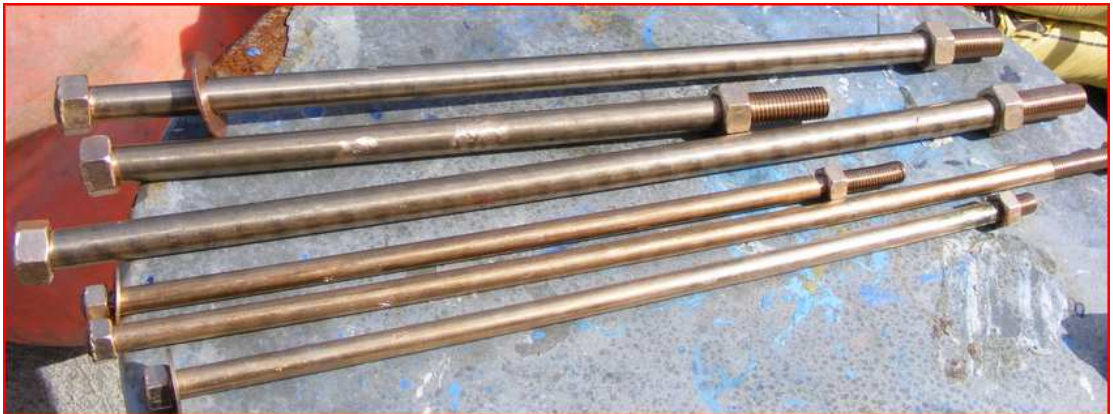
10. Similarly the keel bolts were also made from bronze bar (imperial).
